Annual Report
Grant No. N00014-85-K0179
September 1, 1986 - September 30, 1987

INVESTIGATION OF MICROSTRUCTURAL FACTORS THAT
CAUSE LOW FRACTURE TOUGHNESS IN SILICON
CARBIDE WHISKER/AL ALLOY COMPOSITES

Report No. UVA/525398/MS88/102
September 1987

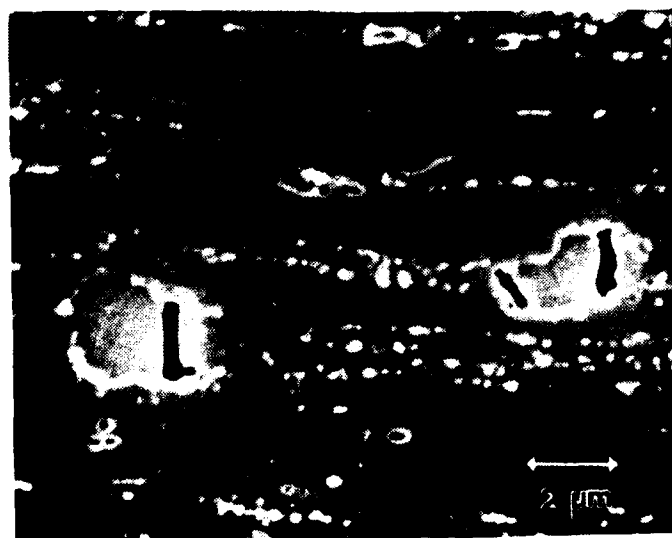
Figure 2. SEM of A-W Containing Particles in 2124
Sample Specimen 114.

Figure 3. TEM of Al-Cu Containing Particles in 2124 Tensile Specimen 1211.

Figures 2 and 3 depict the brittle nature of large precipitates in 2124 Al specimens which were prepared by identical powder metallurgy techniques as the composite, and tested in tension [21]. Although the surrounding matrix is relatively underformed, large cracks are clearly seen to propagate through the particles. Energy dispersive spectroscopy (EDS) has revealed Mn and Fe content in these precipitates.

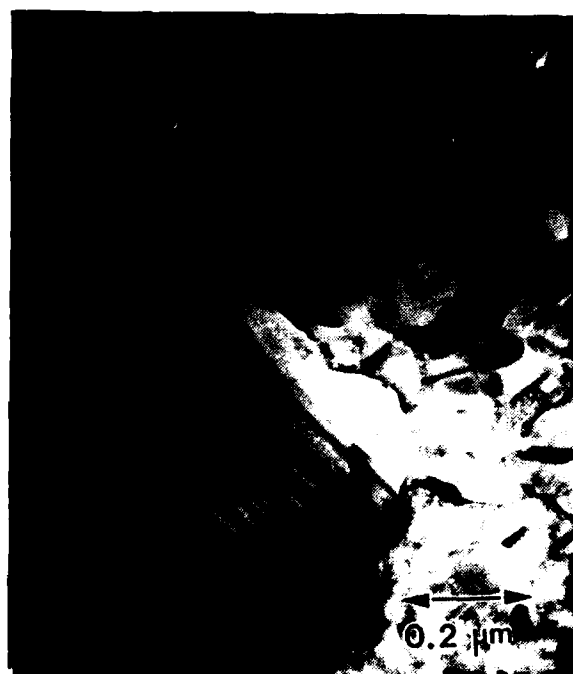
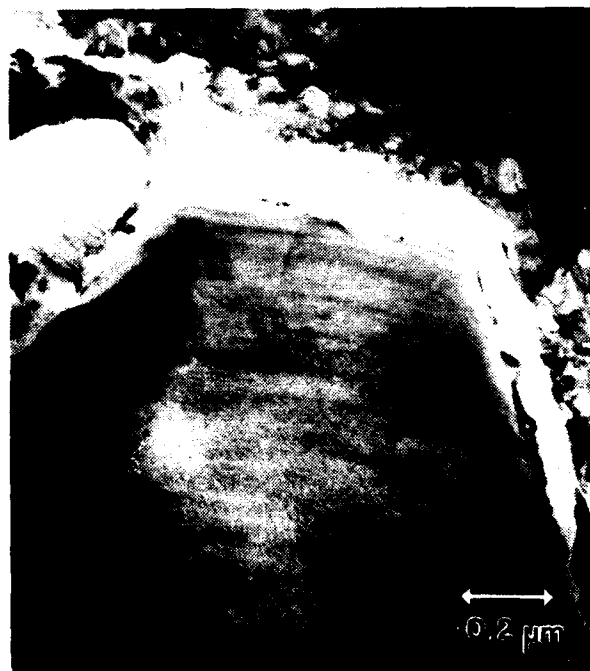
Figure 7. SEM of cavitation at whisker tip
in $\text{SiO}_2/\text{SiO}_2$ film.

Figure 6. SEM Showing Cross Section of Whisker
With Interfacial Failure [21].

Fracture studies by Wawner [21] clearly show the importance of the interface. Tensile fracture specimens of 2124-SiC_w composites were examined with TEM (Figures 7 and 8). Cavities are found to form at whisker tips and along the interface. The same phenomenon of cavity formation was also reported by Nutt and Duva [29]. Any weak bonding between matrix and whisker can cause premature crack initiation in these areas. Correlation of mechanical properties with microstructure in investigations such as these can lead to strengthening theories. However, many fracture studies have not provided detailed microstructural characterization of test specimens, and so application of general theories is difficult [30].

It is interesting to contrast the cavitation in the latter micrograph with that which was shown in Figures 7 and 8. Clearly, a weakly bonded water molecule at the interface, while strong enough to result in good stress transfer to the

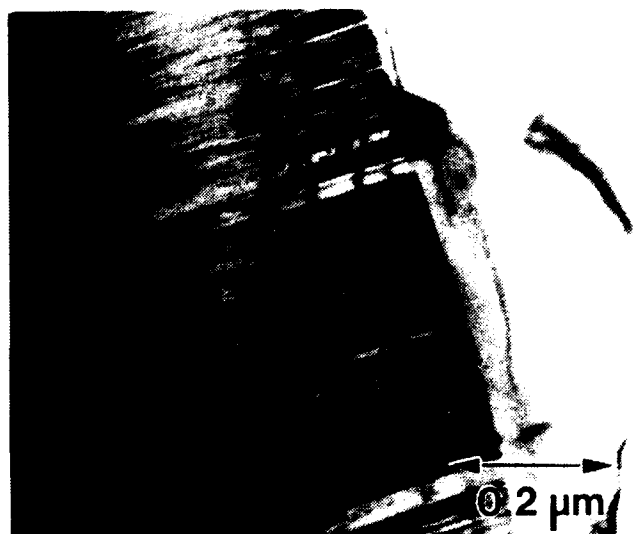
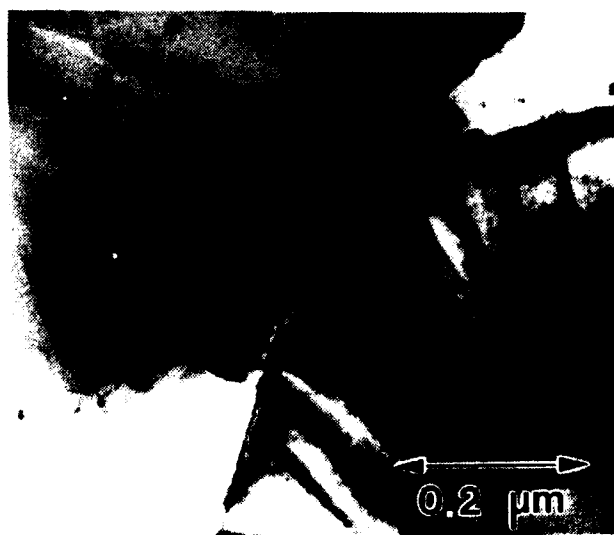
Figure 13. Precipitate Formation Along Interface and at Whisker-Whisker Contact Point

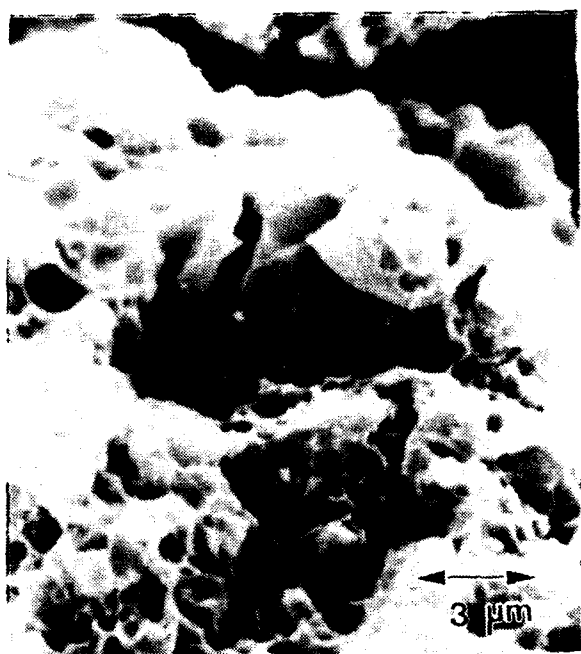
Figure 15. Brittle Intermetallic in 2124-SiC_w Composite and Corresponding X-Ray Spectrum

Past microstructural studies have indicated that constituent particles in the 3-5 micron size range dominate failure in the present composite systems of interest (i.e. SiC/2124 and SiC/6061). These particles, identified through x-ray analysis as: Al_2CuMg , $\text{Al}_{20}\text{Mn}_3\text{Cu}_2$, and FeCuMnAl_6 [38], influence fracture toughness since they generally are brittle and form in critical locations such as whisker-matrix interfaces or along grain boundaries. These particles are also found to form in areas where whiskers are in contact, as shown in Figure 13. This figure is a TEM micrograph of a precipitate formed at the contact area of two whiskers in a 2124 matrix composite. Figures 14 and 15 show SEM micrographs of typical particles on the fracture surfaces of this material. Included is an energy dispersive x-ray spectra indicating that Cu, Fe, and Mn are found in these particles. The particles exhibit cleaved surfaces compared to the ductile appearance of the surrounding matrix. Also seen in Figure 15, is a crack passing through the particle. Pore formation can also be seen.

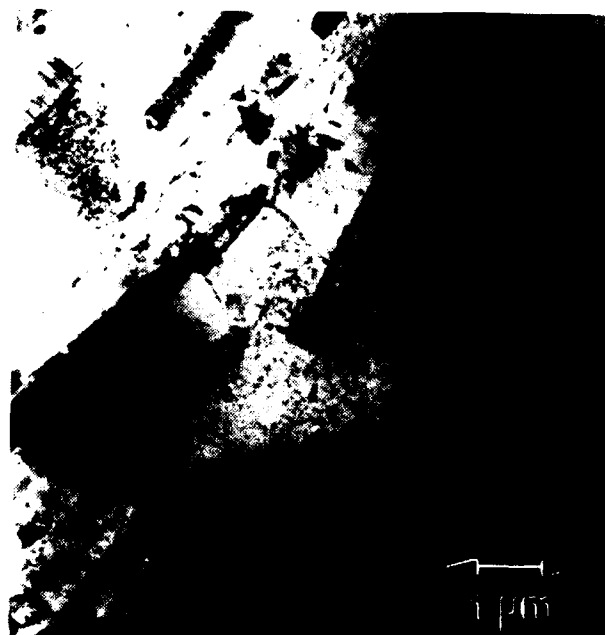
Figure 18. TEM of fine Whisker Distribution and Alignment After Improved Fabrication Techniques

As seen in Figure 16, the new composites exhibit much improved whisker alignment and distribution. Since surfaces for SEM examination of whisker distribution were polished and etched, it was necessary to verify that polishing was not influencing orientation. TEM samples were examined, and found to exhibit the same fine distribution of whiskers, as shown in Figure 18.

Figure 18, the relatively clean matrix is evident. Very few precipitates of sizes larger than whisker diameters (0.5 micron) were found. Attempts to x-ray map areas of Cu and Mg using EDS produced no areas of significant concentration in the new matrix alloys. There are, of course, still some large intermetallics formed, as seen in Figure 19, but they are not very common.

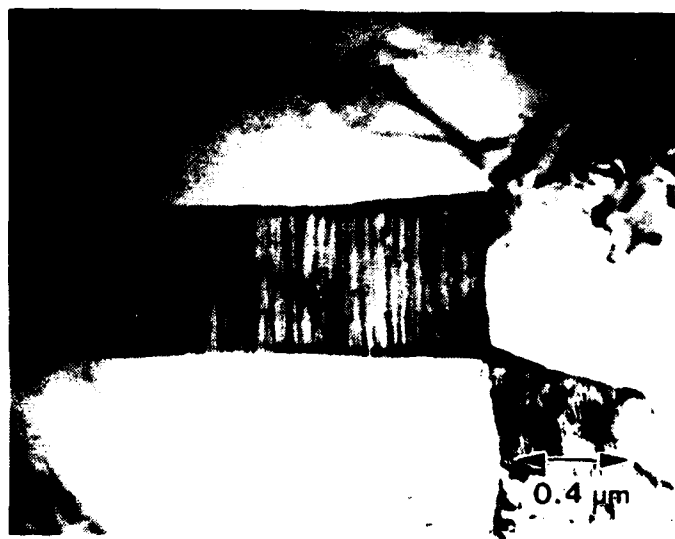
Matrix-whisker interfacial areas are generally very clean in the Al-Cu-Mg and Al-Li-Cu-Mg alloy composites [see Figure 20(a)]. In the Al-Mg binary alloy, however, precipitates are seen to form along the interface [Figure 20(b)]. The large number of brittle precipitates, as previously seen in 2124 and 6061 composites, has been greatly reduced in these new alloys, thus resulting in cleaner interfaces.

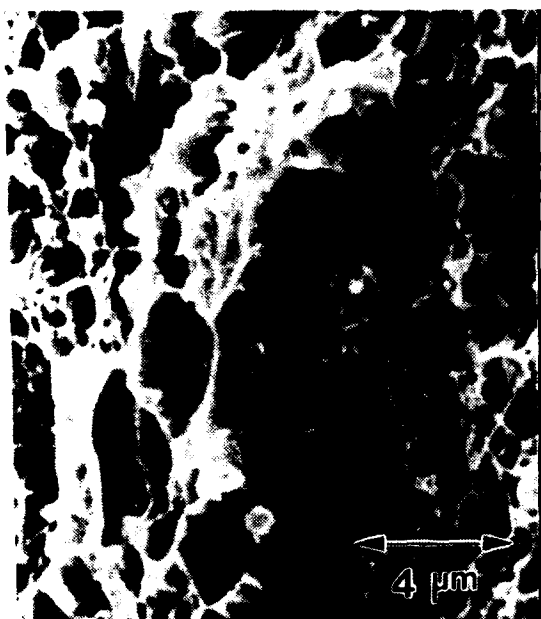
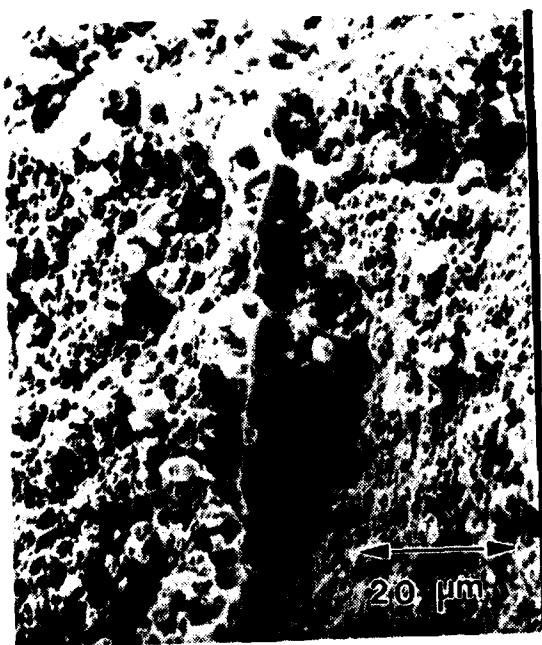
Fracture surfaces in Figure 23 are from extruded 1100 matrix composites, showing similarity between transverse and longitudinal fracture modes. The ductility exhibited by the matrix is quite evident. The same comparison for 2124 is shown in Figure 24. 2124 shows much more porosity and brittle appearing failure in than 1100. This is attributable to the greater amount of brittle matrix precipitates present. An interesting phenomenon observed only in transverse specimens, and in fact, one which was seen in all transverse samples studied, is the large pieces of matrix and whisker conglomerate which are torn out in chunks, leaving behind large pores and exposed whiskers (see Figure 24-b). This result could be part of the reason for lower transverse strength, but the phenomenon is not fully understood.

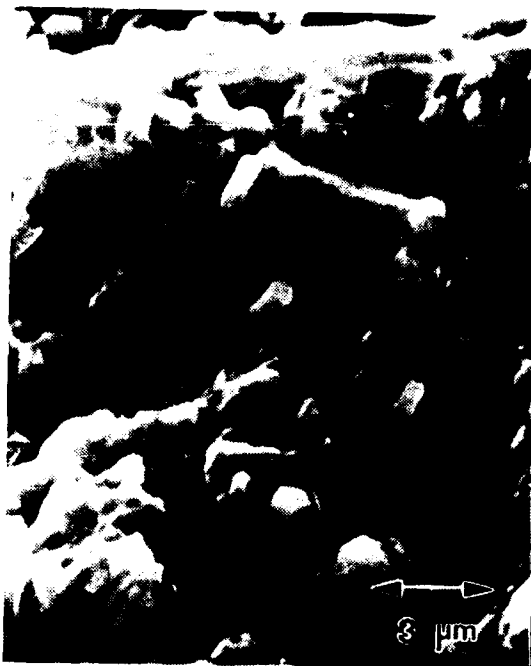
Figure 17. Tensile and Shear Fracture by the Rolling Process: (a) Longitudinal, Al-5Mg, 100°C, 1000 psi, 1000 sec; (b) Longitudinal, Al-5Mg, 100°C, 1000 psi, 1000 sec; (c) Transverse, Al-5Mg, 100°C, 1000 psi, 1000 sec; (d) Transverse, Al-5Mg, 100°C, 1000 psi, 1000 sec.

Transverse and longitudinal fracture surfaces of rolled Al-Cu-Mg and Al-Li-Cu-Mg are pictured in Figure 27. Whisker pullout, both the exposed whiskers and corresponding pores, can be seen in the longitudinal surfaces. These surfaces can be compared with those of material of higher strength in Figure 24. There the material is not rolled and interfacial damage (pullout) is not evident. In the rolled transverse fracture surfaces of Figure 27 and especially in Figure 27(C), the tearing away of material at the whisker-matrix interface is quite evident. Figure 27(D) also shows bundles of whiskers apparently not wetted by the matrix.

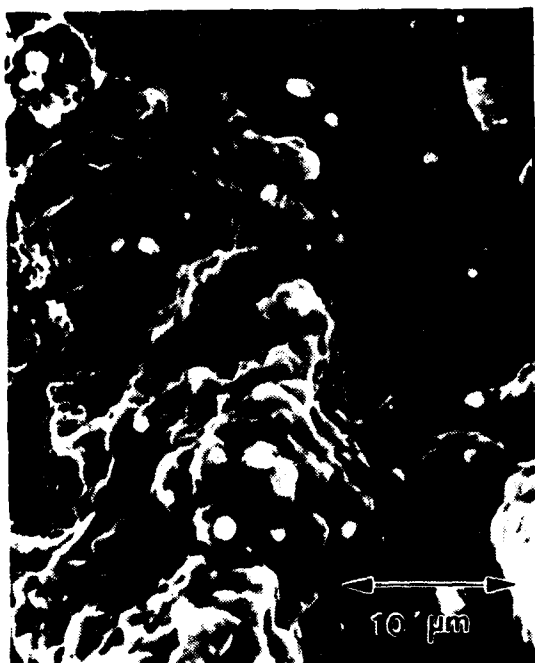
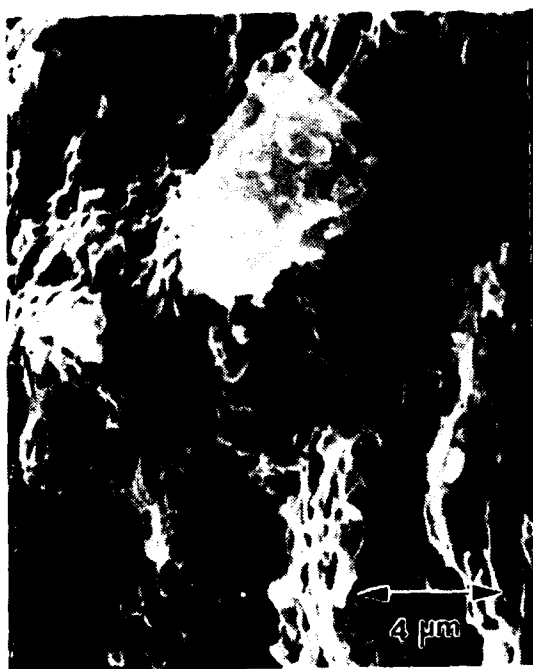
Transverse and longitudinal fracture surfaces of hot-rolled 2124 are shown in Figure 28. These micrographs can be compared to Figure 24, which shows the same material in the unrolled state. Transverse fracture surfaces, before and after rolling appear similar. The longitudinal surfaces also have similar appearances, but there is an unusual observation in the hot rolled surface [Figure 28(a)]. The area pictured, which was a common occurrence across the surface, does not exhibit the usual dimpled structure. Instead, areas of apparent localized incipient melting at a free surface (pores) are found. This melting phenomenon could have taken place during the hot-rolling process. The transverse surfaces again show the pulling away of fiber-matrix conglomerate, as seen previously. The fracture surfaces for 55% rolling reduction do not show any definite microstructural reasons for the observed strength decreases, but it is suspected that some interfacial damage must be incurred during the rolling process.

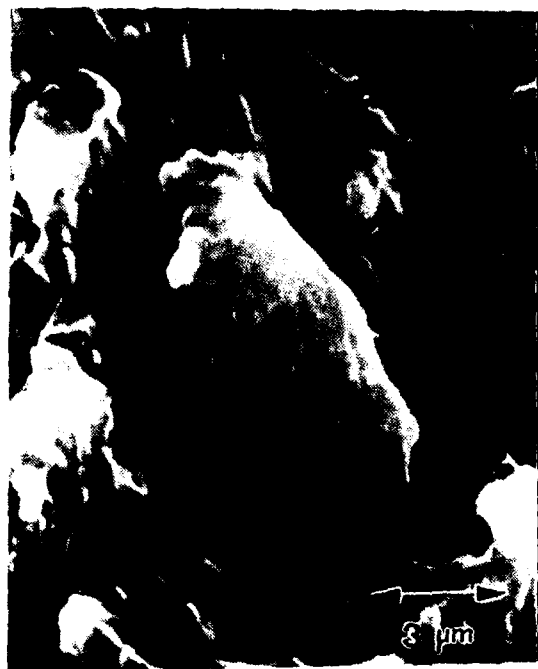
Figure 35. Fracture in 2124 Composite After 270°C Exposure and Corresponding X-ray Spectrum

It is interesting to compare the 270°C treated surface with the 270°C treated surface pictured in Figure 35. Scattered areas of localized heating were found across the surface. There are also the x-ray spectra differences. The heated areas in the 270°C material have much higher Cu content relative to the Al content than does a similar area

of T6 surface. These Cu-rich areas of apparent localized melting are a probable cause of the poor strength properties of the 270⁰C treated material.

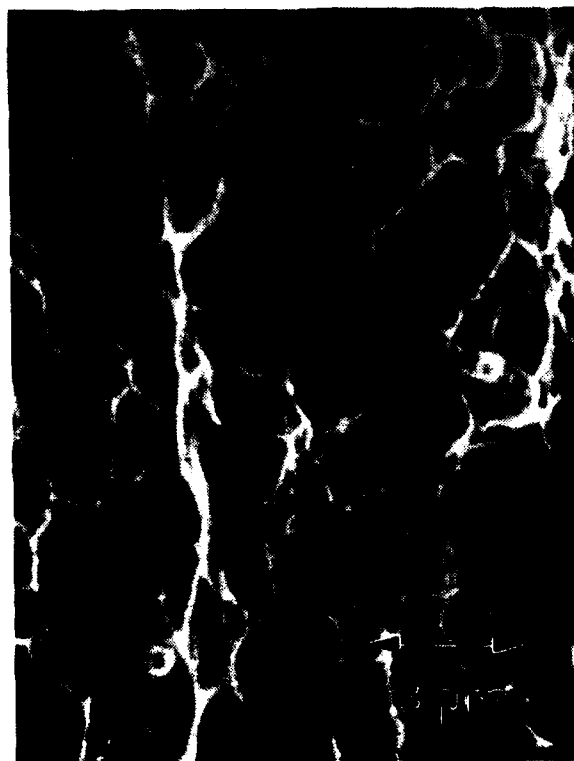
Figure 1. Fracture surface of a high strength extruded sample of 1100/20 v/o SiC_w composite

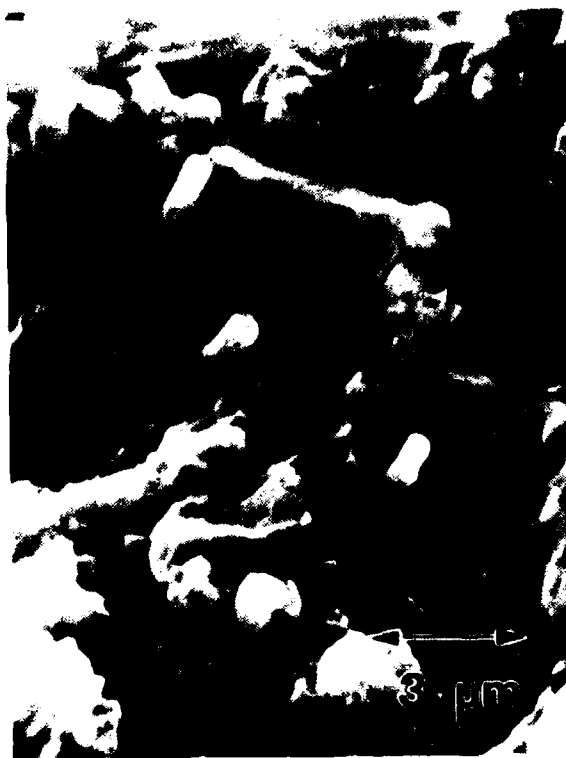
Figure 2. Fracture surface of a rolled 1100/20 v/o SiC_w composite

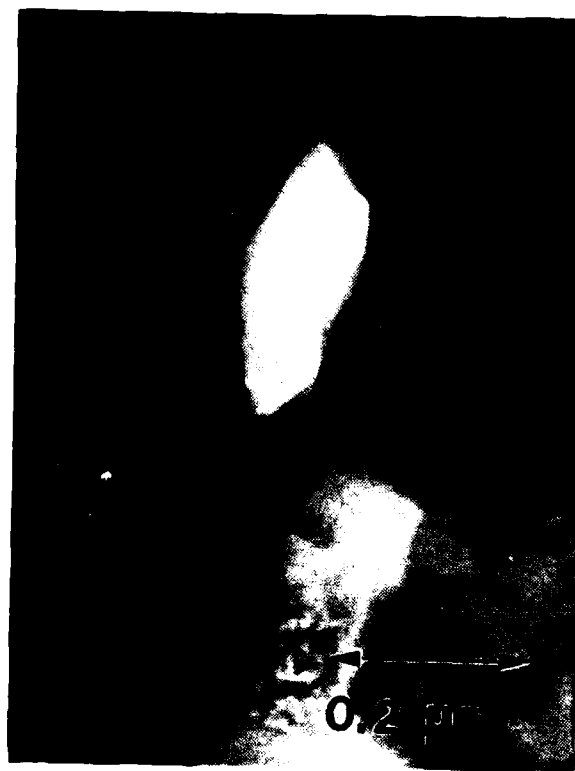
Figure 4. TEM of void at interface caused by rolling

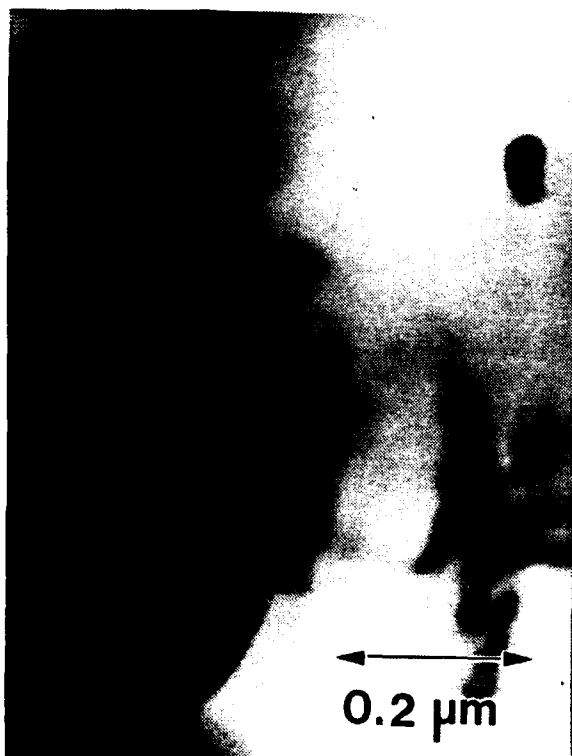
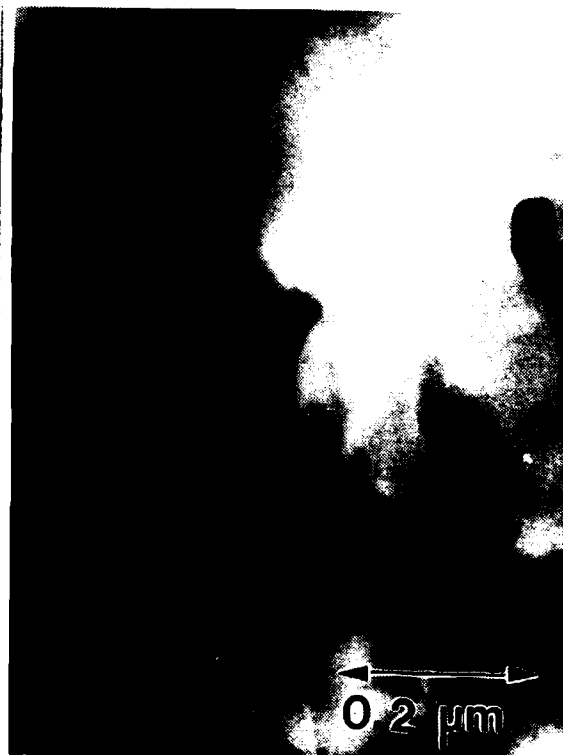
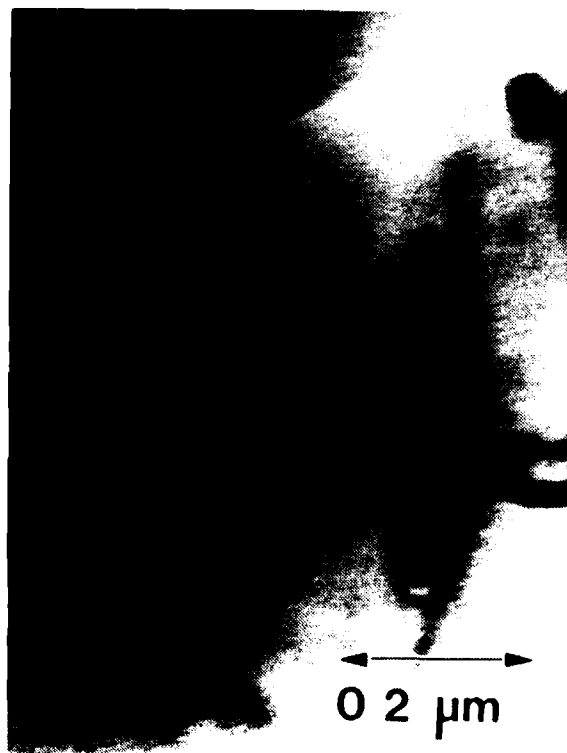
Figure 4. a-f Showing closure of void with time and temperature in in-situ heating experiment
